**FIRE AND EXPLOSION GROUP
FACTUAL REPORT OF INVESTIGATION**

Fire and Explosion Group

Group Chairman's Factual Report

NTSB File # HWY-05-MH-035

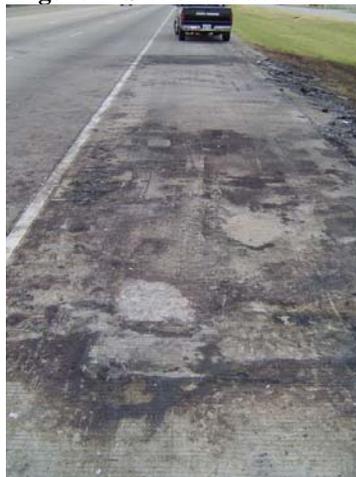
The accident site was located on the right shoulder of I-45N, near the Beltline Road overpass (Figure 1). The road surface was stained by fire debris (Figure 2), and a grass fire had spread from the motorcoach east toward the service road. The concrete road surface appeared to have a localized area

Figure 2: Fire debris stained roadway

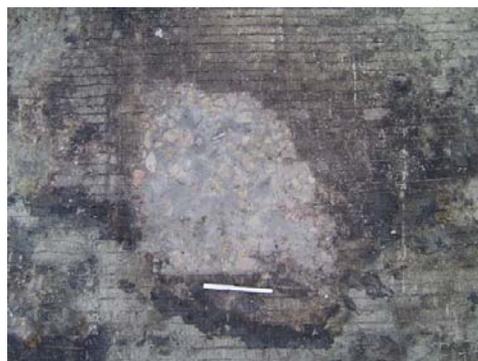
of spalling¹ where the rear of the motorcoach was located during the fire (Figure 3). After the fire, the roadway had been cleared of debris using a skid steer type loader.

Figure 3: Concrete spalling, shown with pen for scale

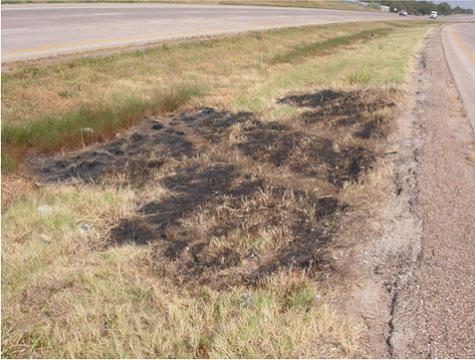
On the day of the accident at a location approximately 3.2 miles south of the accident site (at exit 266) a grass fire occurred along the median between the northbound and southbound lanes (Figure 4). The fire was reported to the Ferris Volunteer Fire Department prior to the accident at 6:04am. In the middle of the burnt patch of grass, two small metal objects were found (Figure 5). These metal objects were similar in appearance to metal objects recovered from the tag axle spindle assembly of the accident bus.

Figure 4: Grass fire site

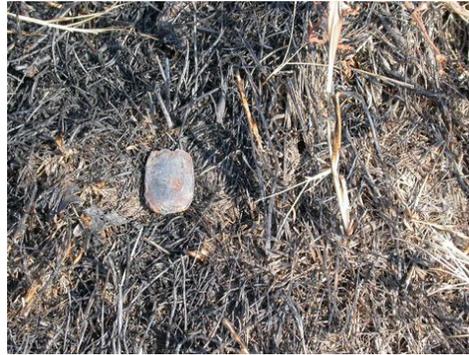
Figure 5: One of the metal object found at grass fire site

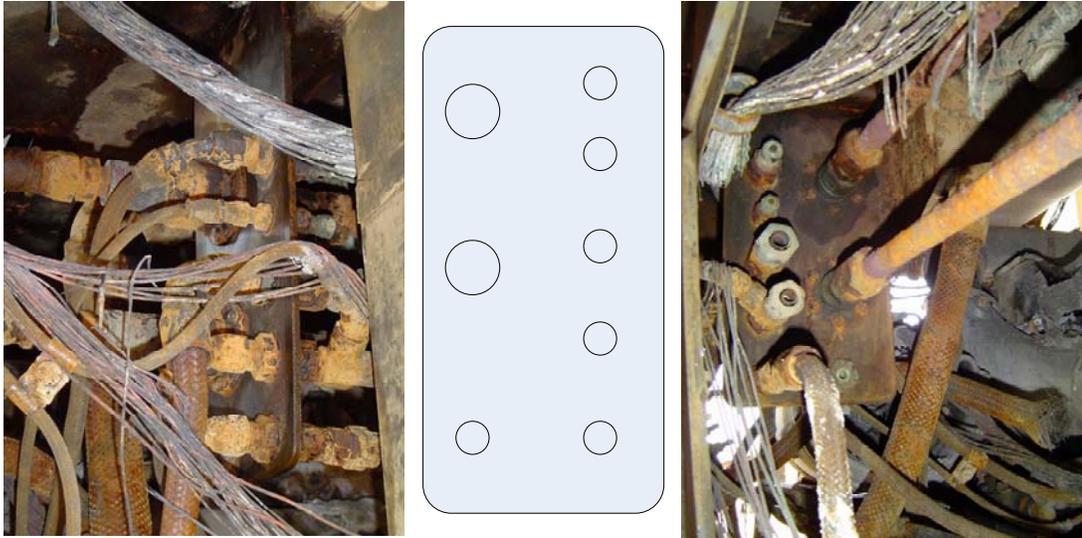
Figure 6: Manifold in engine compartment

The fuel system was examined from the fuel tank to the engine and back. The flexible supply line from the fuel tank was consumed by fire starting less than a foot from the tank all the way to the connector on the manifold located in the engine compartment (Figure 6). From the manifold, the braided steel line to the primary fuel filter appeared intact. The shut off valve was attached to the end of this line, but was separated from the primary fuel filter. Only a portion of the primary fuel filter remained on the engine. This portion was the part that bolted on to the engine block and was the location where the fuel lines were connected and the filter canister would attach (Figure 7). This component shows signs of severe heat exposure.

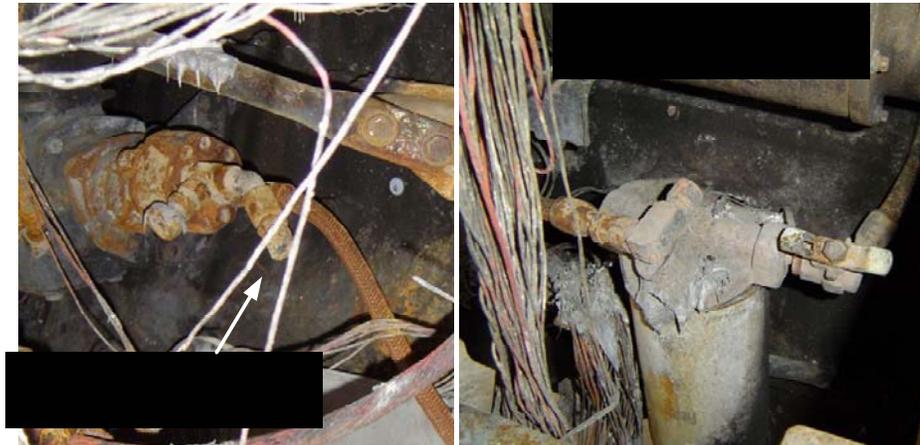
Figure 8: Fuel pump and secondary fuel filter

The braided steel hose line from the primary fuel filter to the fuel pump was missing (Figure 8). The braided steel line from the fuel pump to the secondary fuel filter was intact. The line from the secondary fuel filter to the engine appears intact. The braided steel return line from the engine to the manifold was intact. The braided steel fuel line from the primary fuel filter to the heater unit was disconnected from the fuel filter's mounting bracket (Figure 7) but otherwise intact up to the heater unit. From the heater unit the return fuel line is intact up to its connection on the manifold. From the manifold the flexible return line to the fuel tank was consumed to less than a foot from the tank.

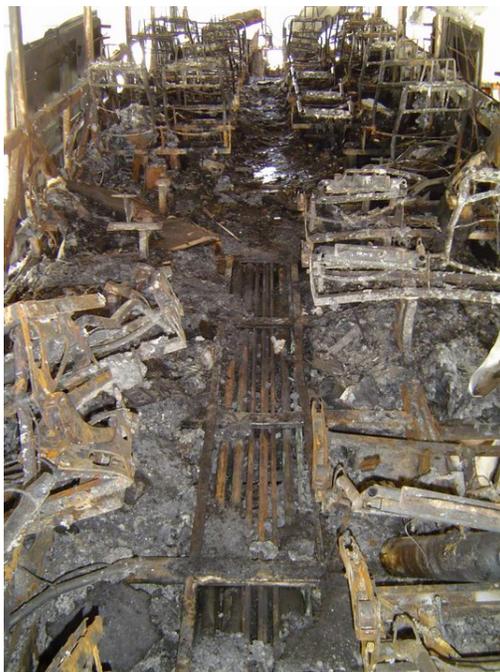
Figure 9: Tunnel under floor

Along the centerline between the left and right rear wheel wells, the fuel lines run beneath the passenger cabin floor along a service tunnel together with power steering and coolant lines (Figure 9). There are two fiberglass cover panels located underneath the motorcoach in the wheel well area. The cover panels facilitate access to this service tunnel from the outside. The rearmost cover was consumed by fire (Figure 10), creating an opening to the passenger cabin floor, and exposing the fuel lines (which were consumed by fire) and other lines. The other lines were metallic and remained intact. The forward access cover was charred but remained in place.

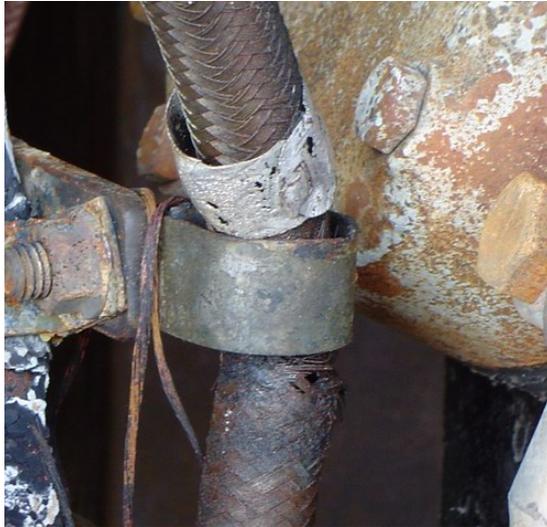
Figure 13: Chaffed line from hydraulic fluid reservoir

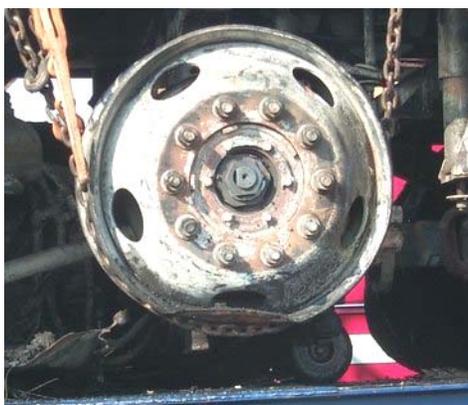
Figure 16: Tag axle passenger side

The right side tag axle tire was missing and the rim had a flat spot on its outer perimeter (Figure 16). The rims on the tag axle were steel. The drive axle inner tire (Figure 17) was mounted on a steel rim which appeared intact. Approximately a 24" footprint of tire, including the corresponding section of sidewall, was unaffected by the fire. The remaining portion of the tire was heavily damaged by fire. The tread separated from approximately the 8 o'clock thru 2 o'clock position (viewed from outboard side). The belts were frayed on some areas at the 1-2 o'clock position on the inside face. The tread was missing from 8-12 o'clock position.

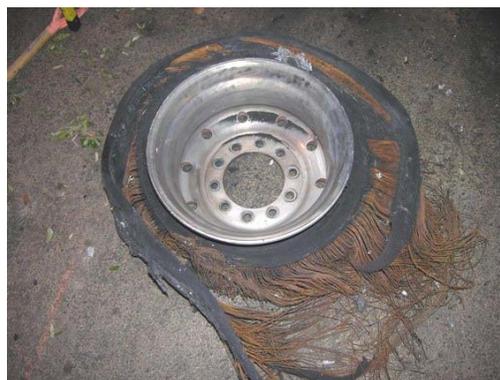
Figure 18: Right drive axle outer

The drive axle outer tire (Figure 18) was mounted on an aluminum rim which appeared intact. Approximately a 24" footprint of tire was unaffected by fire. The corresponding section of sidewall was also unaffected. The remaining portion of tire was heavily damaged by fire. The tread separated from approximately the 7 o'clock thru 2 o'clock position (viewed from outboard side). The tread was missing from 7-12 o'clock position.

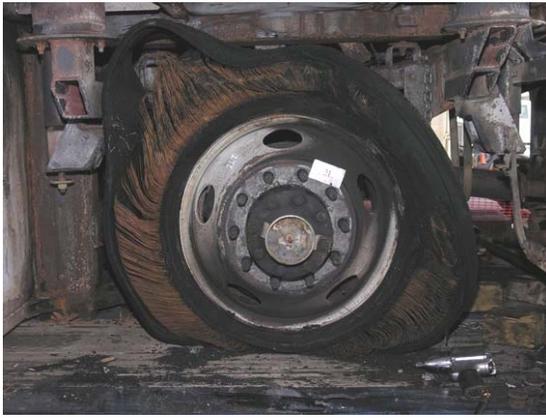
Figure 19: Left side drive axle inner

The drive axle wheels on the left side were not removed from the vehicle at the time of the inspection, so only a limited examination was possible. The left side tag axle rim appeared intact. This was a steel rim. Approximately a 12" footprint of tire was unaffected by fire. The drive axle inner tire (Figure 19) was mounted on a steel rim which appeared intact. Approximately a 14" footprint of tire was unaffected by fire. The remaining portion of tire was heavily damaged by fire. The tread separated from approximately the 3 o'clock thru 12 o'clock position (viewed from outboard side). Complete tread was visible around the tire. The drive axle outer tire (Figure 20) was mounted on an aluminum rim. The rim appeared intact. Approximately a 9" footprint of tire was unaffected by fire. The remaining portion of tire was heavily damaged by fire. The tread separated from approximately the 3 o'clock thru 9 o'clock position (viewed from outboard side). Complete tread was visible around the tire.

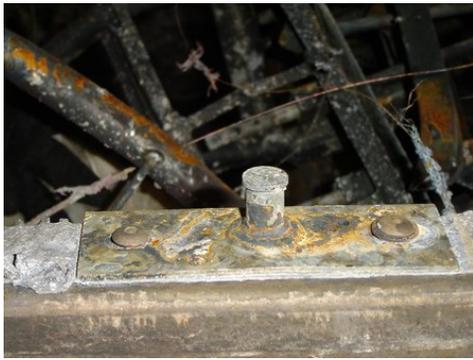
Figure 21: Window release pin

All window frames were missing from the left side of the motorcoach. The steel window release pins (Figure 21) were in place and intact with no obvious signs of deformation. One exception was the forward release pin at the #2 window (counting from the front). This release pin was not the same type as all others, and appeared to be a Torx⁴ screw. All latch mechanisms were missing from the window release pins except for the forward mechanism at the #7 window, and both mechanisms from the #3 window were in place. One of the latch mechanisms from the #3 window is shown in Figure 22.

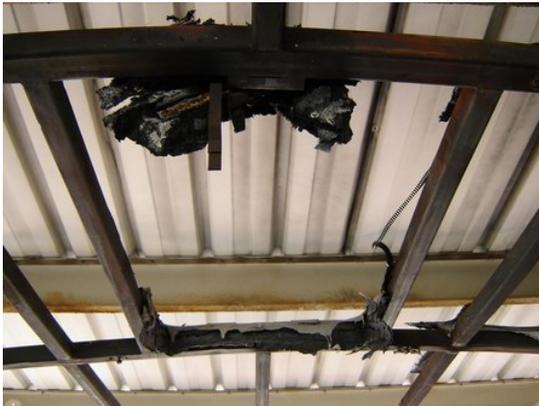
Figure 23: Forward overhead hatch

The ceiling of the motorcoach had two ventilation hatches one towards the front and one towards the rear. When this type of hatch is in the open position it is either held open by a prop rod or it can be rotated by 180 degrees to rest on the motorcoach's roof. Both of these hatches were consumed by the fire. The forward hatch frame had some partial remains in place (Figure 23), and the latching mechanism was found in the latched position. The rear hatch was completely missing, except for the latch mechanism (Figure 24), which was found in the latched position.

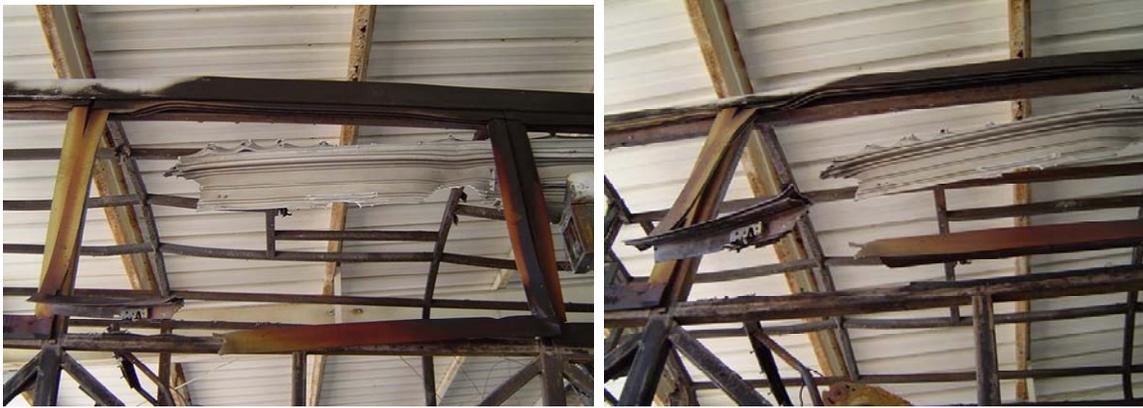
The right side of the motorcoach had all the aluminum window frames in place. All window frames were closed and in the latched position, except for the #6 location. Here, the frame was broken on the bottom, and the bottom edges were twisted outward, as well as downward (Figure 25). The latches on this window frame were found in the open position. The latch pins were bent up and inward (Figure 26). Witness⁵ marks are on both sets of pins and latch mechanisms in this window location.

Figure 25: #6 right side window frame

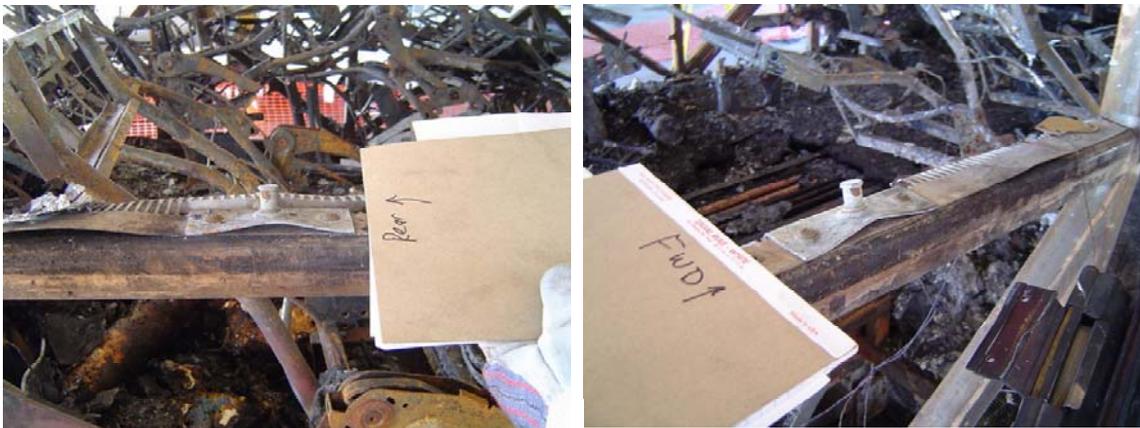
Figure 26: #6 right side window, bent latch pins

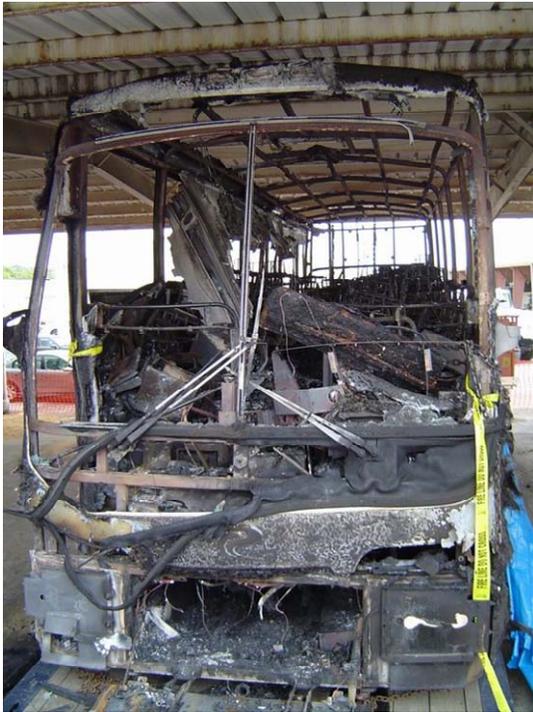
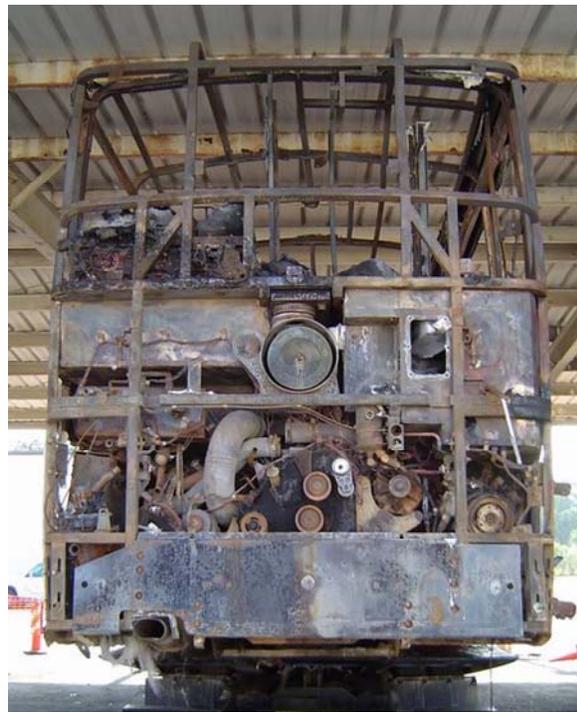
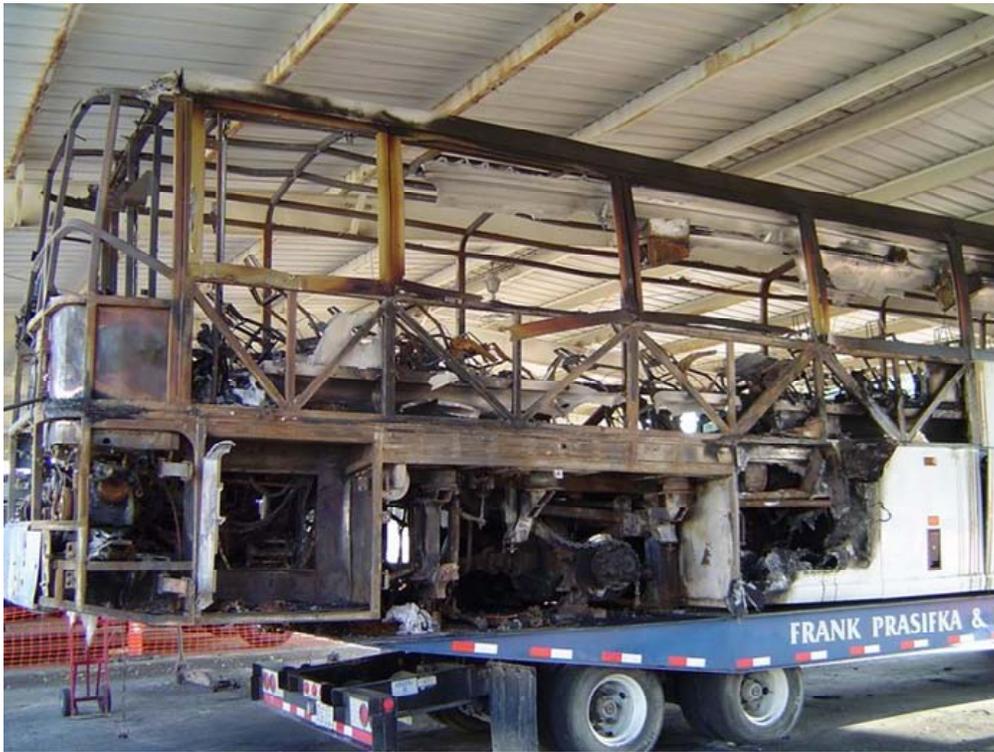
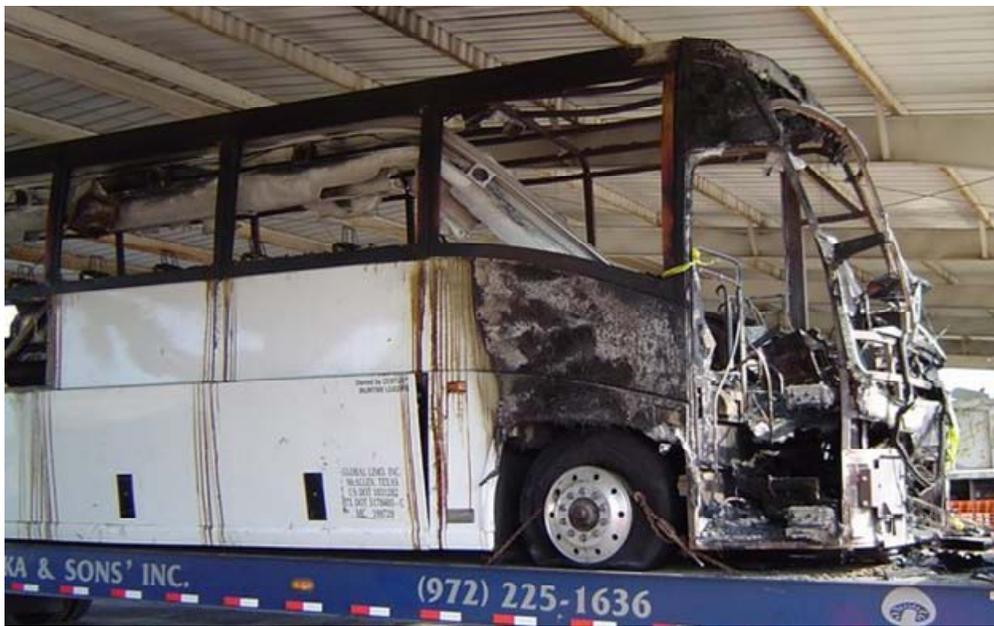
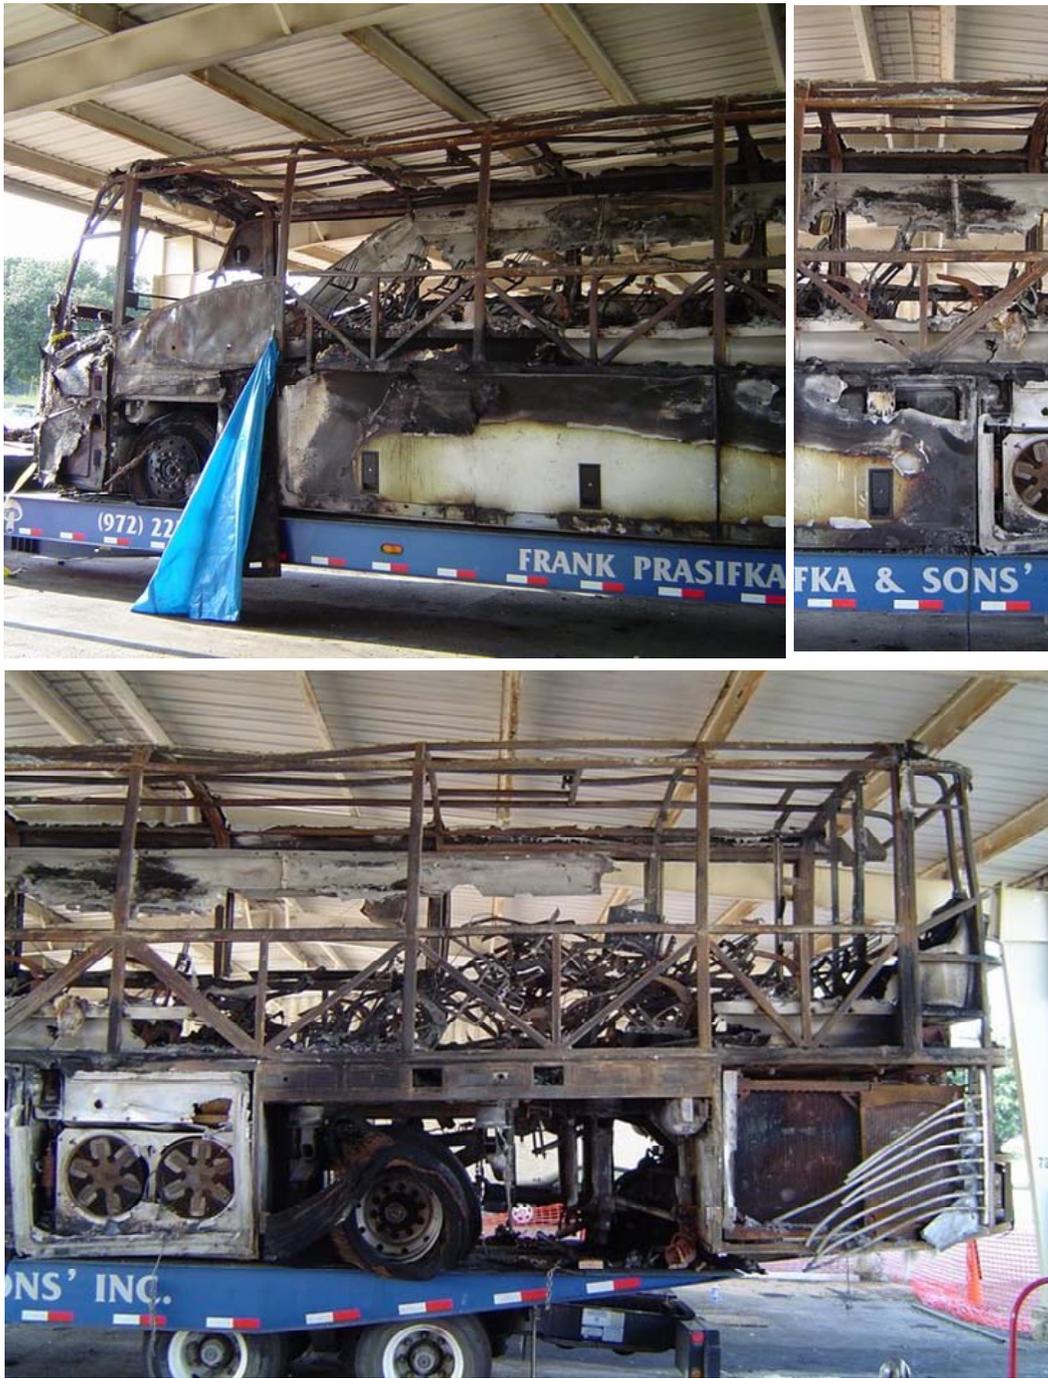
The exterior of the motorcoach was heavily damaged by fire (Figures 27, 28, 29). The right side was damaged to a lesser degree than the left side. From the windows upward only the tubular steel framework and some window frames remained. The tubular steel frame showed signs of bending and buckling which were especially pronounced in the roof area. Most of the window glass was missing. Small traces of glass could be seen in some of the window frames that remained in place. The roof was consumed by fire and so were the body panels at the rear of the motorcoach. A visible outward bend of the window side steel frame above the right rear wheel well area was evident. The outward bend was several inches but less than a foot.

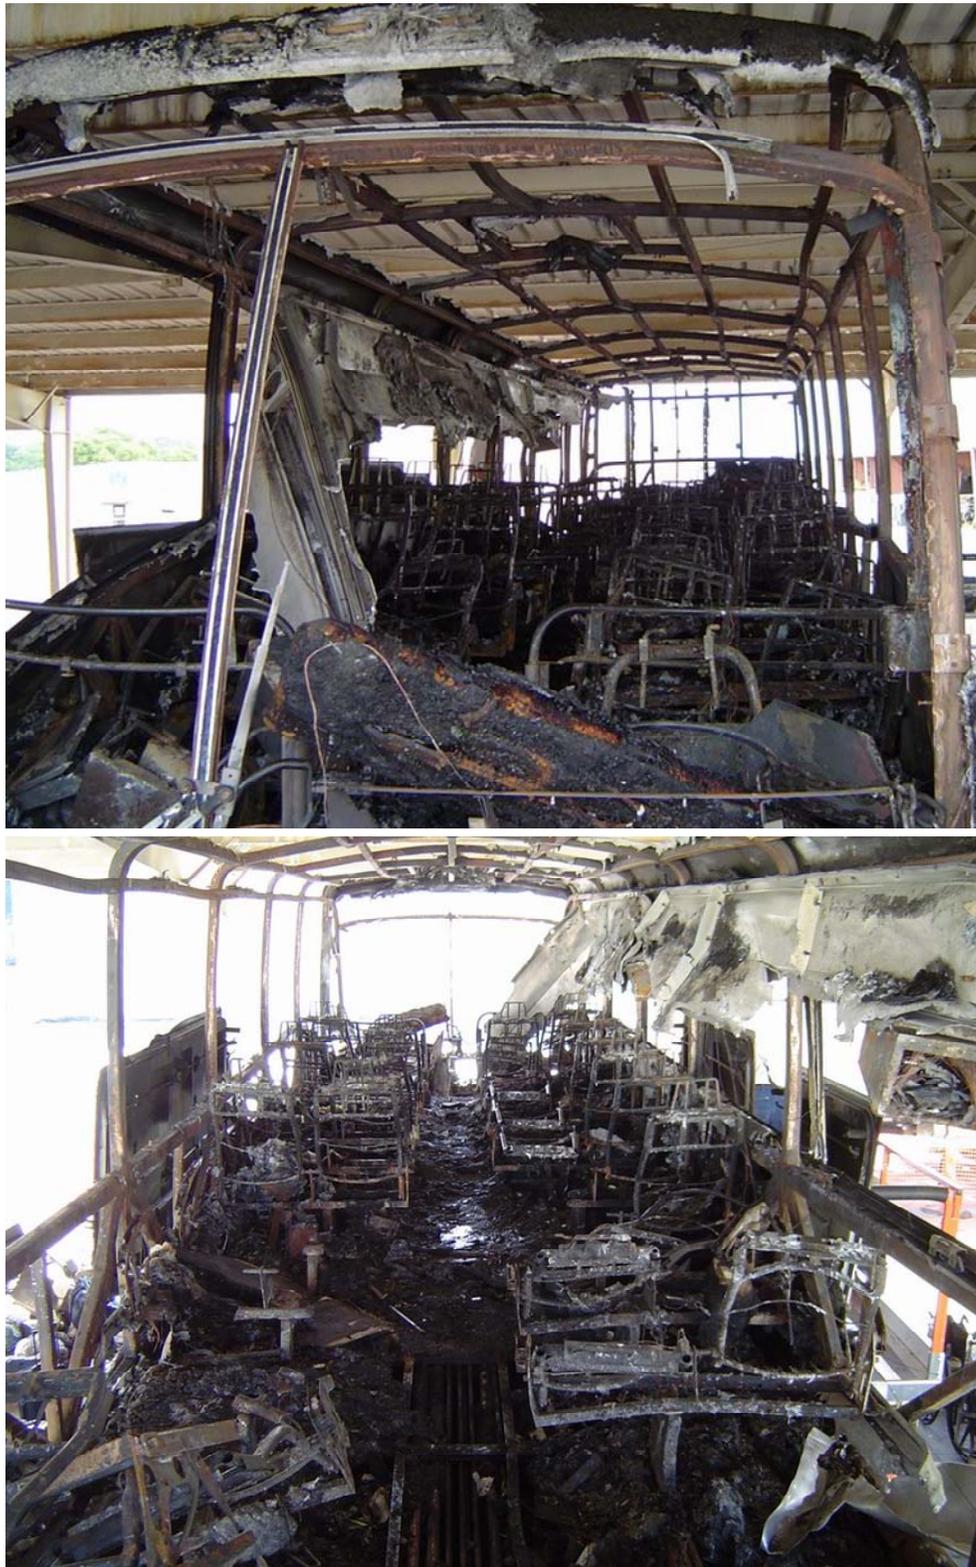
Figure 31 (Interior views)

The interior of the motorcoach was heavily damaged by fire (Figure 31). All the seating materials were consumed leaving the bare metal frames behind. The interior panels were also consumed. Most of the aluminum components were consumed or melted throughout the motorcoach, although the right side of motorcoach appeared to have slightly more aluminum materials remaining than the left side. The ceiling structure was completely consumed by fire as was nearly the entire overhead baggage compartment. Only portions of the overhead aluminum extrusion remained along the right side of the motorcoach. The wooden floor was consumed in the rear of the cabin, along the service tunnel in the middle of the aisle way. The left side of the motorcoach had 14 rows of seating. Rows 8, 9, 10 were extricated for recovery of bodies. The right side had 13 rows of seating. The aisle seats in rows 7 and 8 were extricated for the recovery of bodies. The lavatory in the rear was totally consumed in the fire.

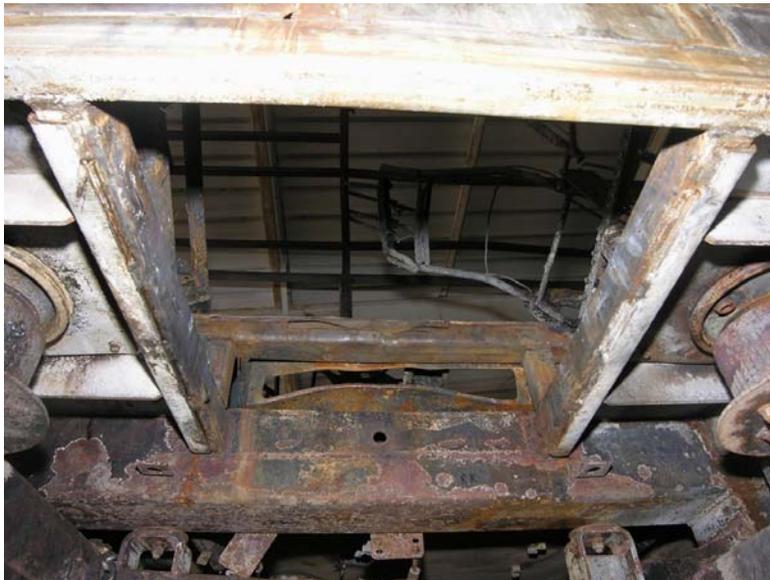
A steel sheet metal floor panel originally located above the right tandem wheels of the drive axle was separated from the frame creating a large opening into the passenger cabin (Figure 32). The floor panel was found lying loose on the trailer during the examination. At the scene of the accident, this piece of sheet metal was found separated from the frame and resting aft and inward of the dual wheels. This was determined from photographs taken at the scene of the accident before the motorcoach was prepared to be moved. The panel was deformed and the lip along the perimeter had been flattened into the plane of the panel (Figure 33). The floor panel was sent back to the metallurgical laboratory in Washington DC, for further examination. The findings of that examination are included in separate report. There were triangular tabs of sheet metal from the floor panel still attached to the frame at 7 of the 16 weld locations (Figure 34). The welds were approximately 2 inch long lap joints. A lateral frame tube, to the rear of this opening was broken at the inboard weld, and bent down (Figure 34). The inboard longitudinal frame portion showed slight localized depressions on the bottom and outer face (Figure 35). The floor support welded to this frame was bent downward and the bottom lip of the return air duct opening was bent upward (Figure 35). The end cap of this return air duct was bent rearward (Figure 36). The wood floor above this panel was consumed by fire. The seat frame that was fastened in this area, above the rear drive axle, had been pulled from its fastening point. The seat track showed evidence of an upward pullout of the seat fastener (Figure 37). The steel seat leg was twisted out of plane, and free from the seat frame and the floor track.

Figure 32: Opening above rear right side dual wheels

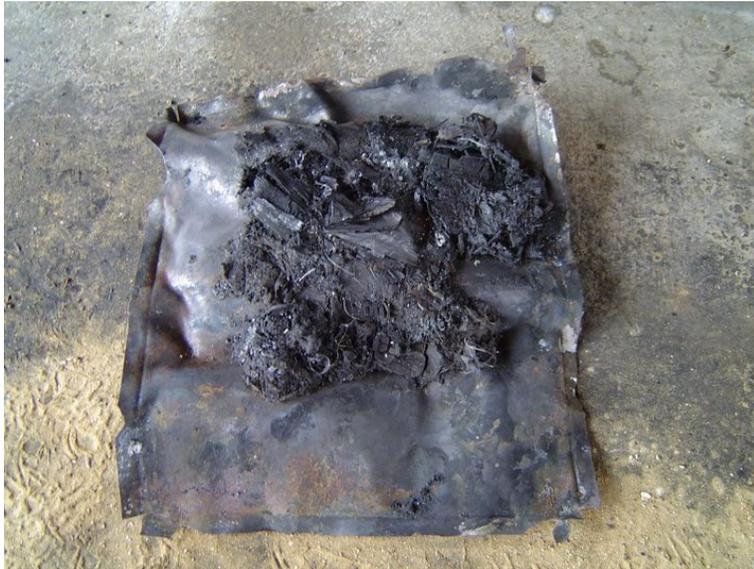
Figure 33: Sheet metal floor panel

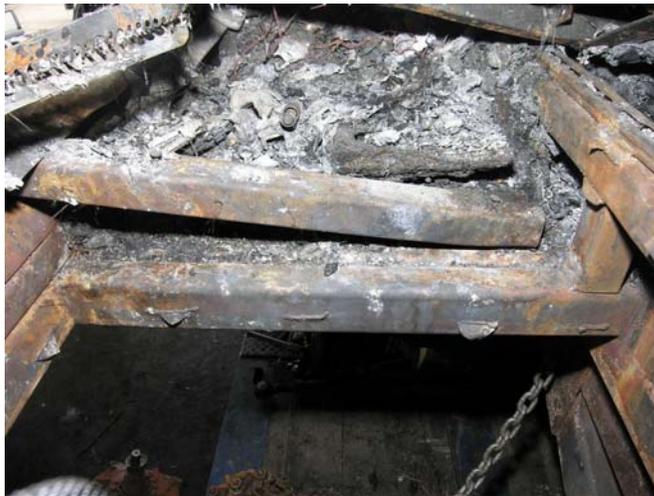
Figure 34: Torn sheet metal and a separated structural member

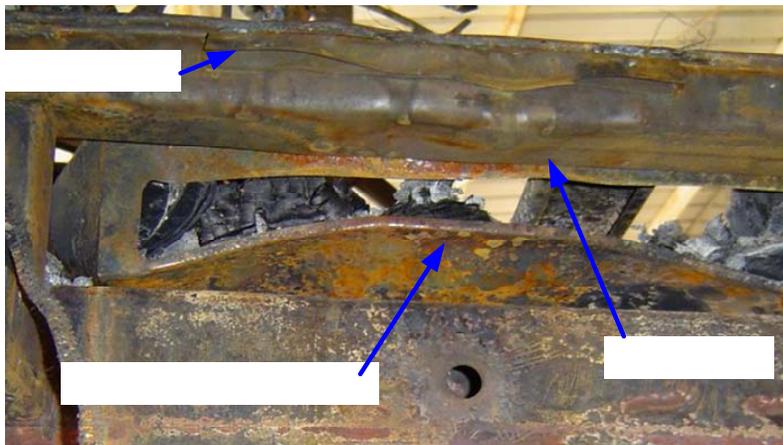
Areas along the inside surface of the ducting fore and aft of the missing sections were relatively free of soot, followed by increasing signs of heavier sooting. The recirculation duct in the right rear wheel area was missing, and the steel portion feeding the return duct was damaged and bowed in an upward direction (Figure 35).

Figure 35: Damage above right side dual wheels

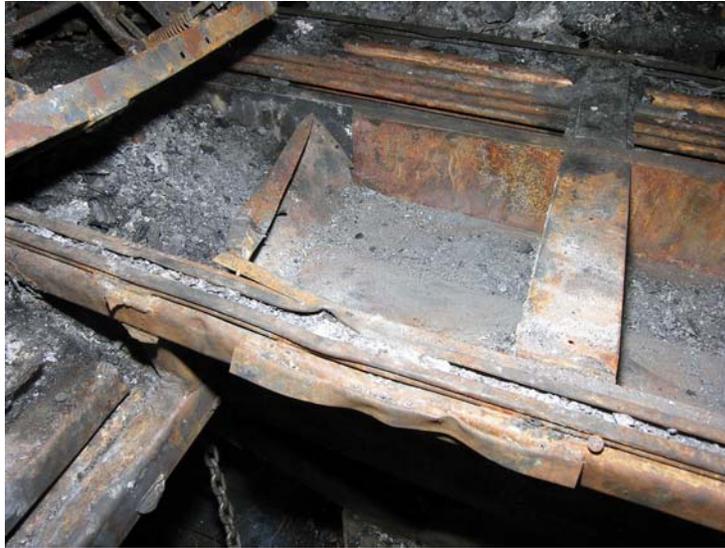
Figure 36: Damage to return air duct end cap

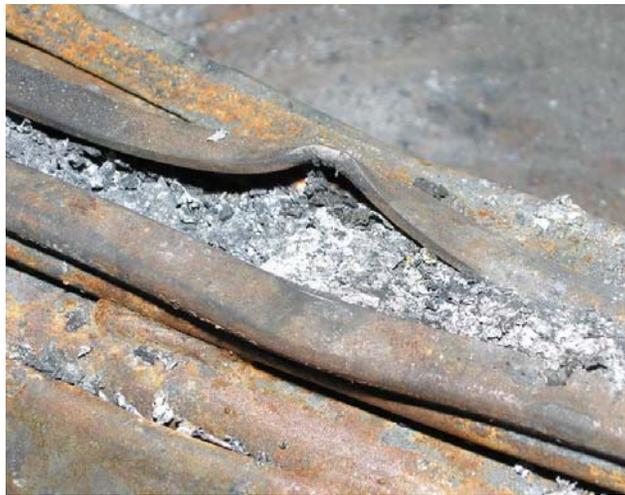
Figure 37: Seat track fastener pull out

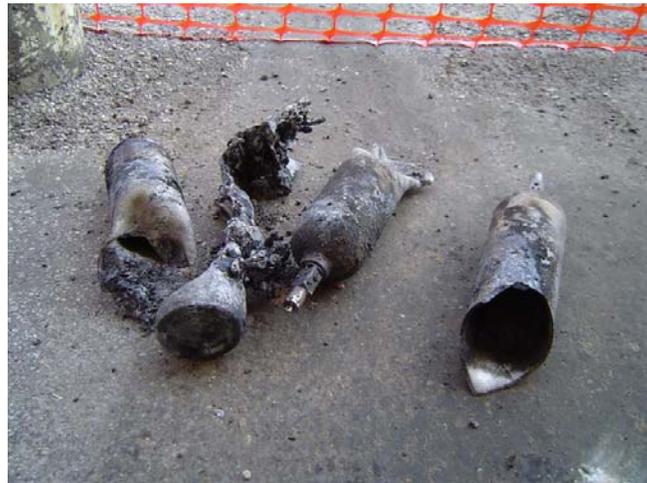
Figure 38: Cylinders found in passenger compartment

Eleven aluminum oxygen cylinders were found inside the passenger cabin. These cylinders were of the DOT-3AL⁸ type. Seven intact cylinders were located in the right side baggage compartment behind the second door from the front, and were covered with soot. Of the 11 in the cabin, 5 were visibly damaged and 6 appeared intact. Of the 5 damaged bottles, three showed signs of severe melting (Figure 38), one had the top valve stem missing, and one showed signs of mechanical damage with sharp fracture surfaces (Figure 39). The locations of recovery of the cylinders found in the passenger cabin are shown in the following table.

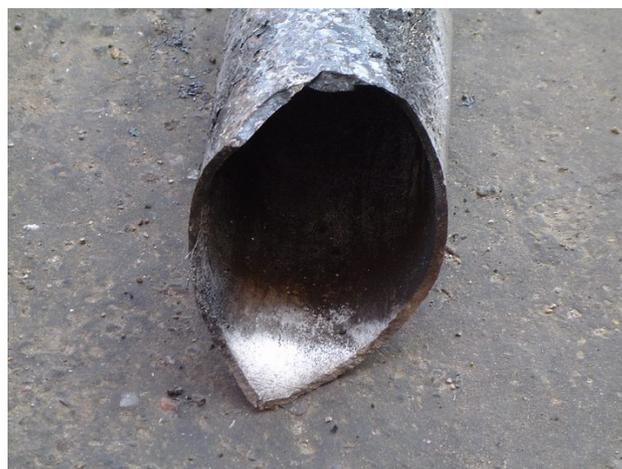
Figure 39: Fracture surface on Aluminum O₂ cylinder

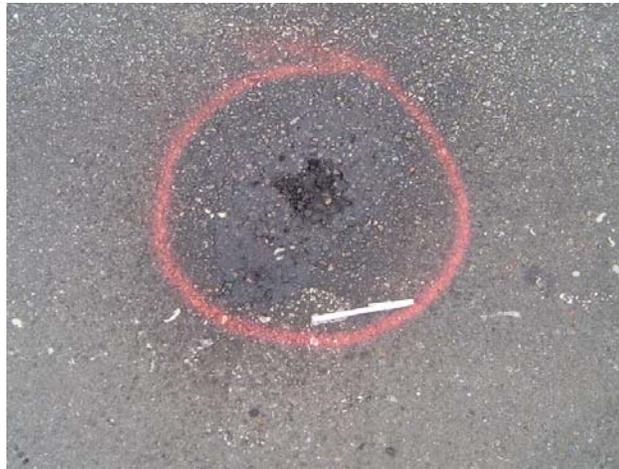
At the time of the tire change in Corsicana, the right rear tag axel tire was changed. This exact location was visible on the roadway, identifiable by the terminus of the skid mark. At a position aft and center of this wheel location, a fluid spill was found (Figure 40), and a sample of contaminated asphalt from this spill area was recovered for analysis. A lock washer was also recovered from the roadway in this general area. At the maintenance depot where the examination took place, fluid and other material samples were removed from the accident motorcoach and shipped to headquarters for further examination and analysis. A complete list of these samples follows in table 2. The sheet metal floor panel from the right rear wheel well area, which was found separated from the vehicle, was sent to the Materials Laboratory at headquarters (Figure 33). Samples of fiberglass exterior body panel and the foam insulation located behind it were removed for future examination.

Figure 40: Liquid spill on roadway
